Home Inspection Report

123 abc Road, mytown, AR 12345

Wednesday May 5, 2021

Skyline Inpections LLC
115 Bold Springs Road
Strawberry , AR 72469
(870)232-1249
tombaker@skyline-inspections.com

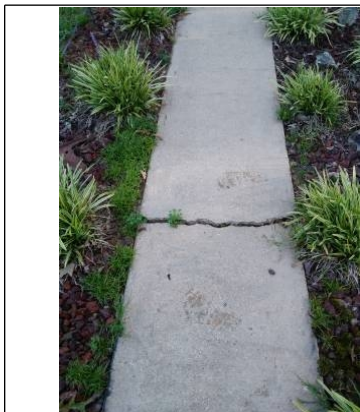
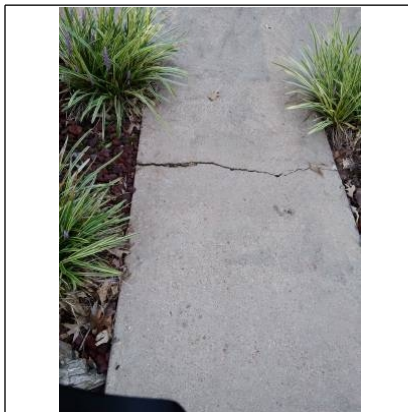
Service Walks

Condition Marginal Trip hazard Settling cracks

Comments Uneven slabs in walks, a tripping hazard, recommend repair and/or replace

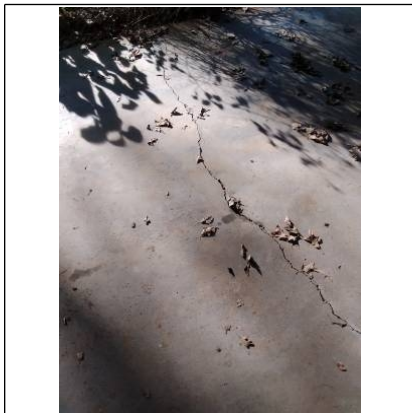
Driveway/Parking

Condition Satisfactory Typical cracks

Comments Driveway had some settlement, but usable, recommend repair

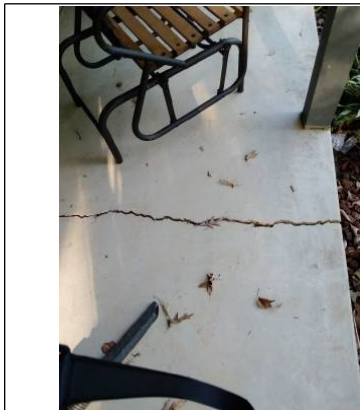
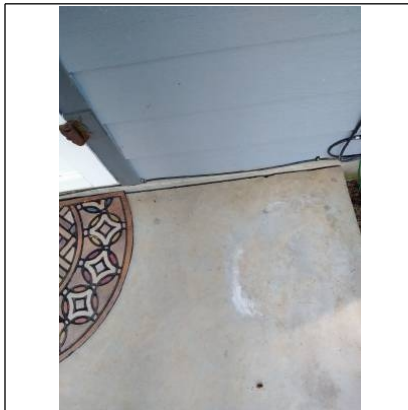
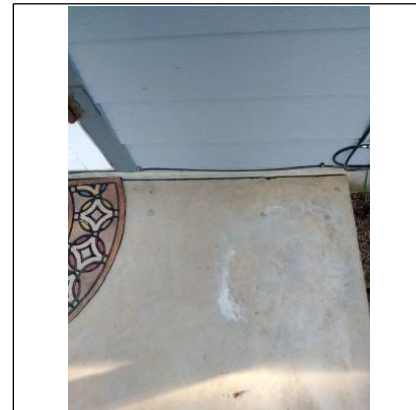
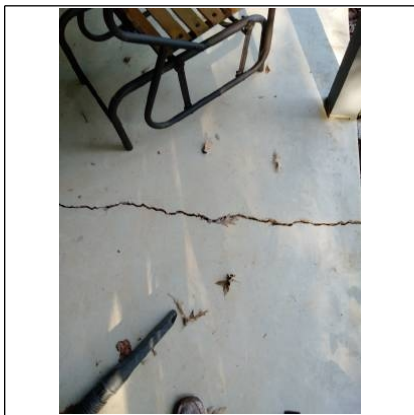
Porch

Condition Marginal

Comments Pitched toward house and separation between porch and house foundation. Broken across porch. Support pier(s) are not properly supported, recommend repair by a qualified technician

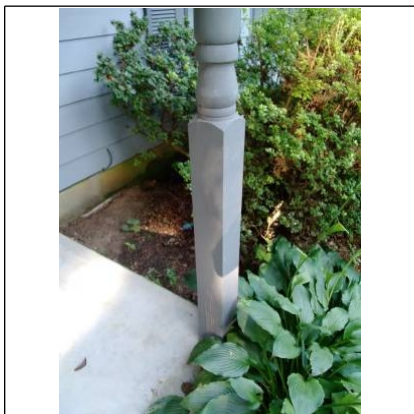
Deck/Patio/Porch Covers

Condition Poor Posts/Supports need Repair

Recommend Improper attachment to house

Comments Post support loose. Safety Hazard

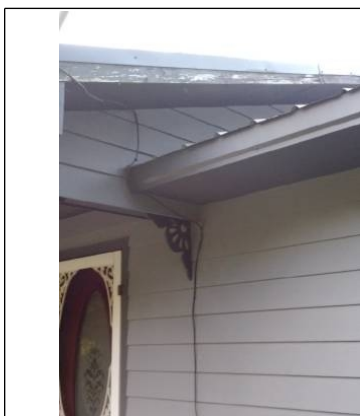
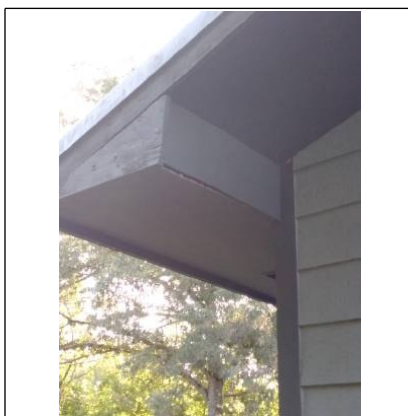
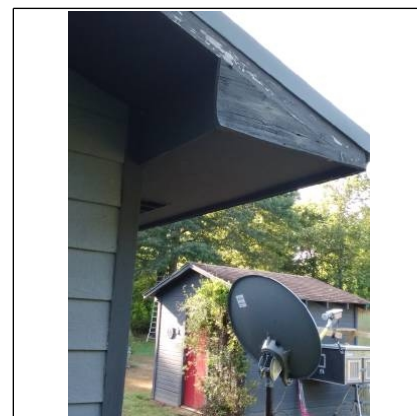
Ventilation System

Comments Soffit/Eave shows some water damage and peeling paint
Gable
Recommend additional ventilation

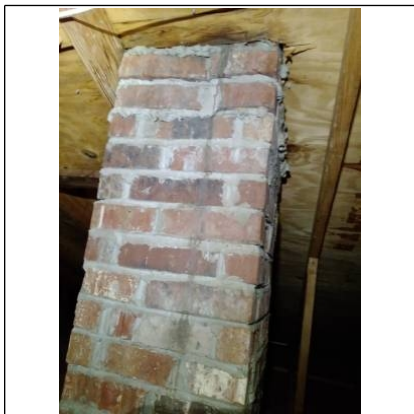
Chimney(s)

Comments Water staining visible. Not wet at time of inspection.
Recommend installing rain cap/spark arrestor

Evidence of Not evaluated Have flue(s) cleaned and re-evaluated

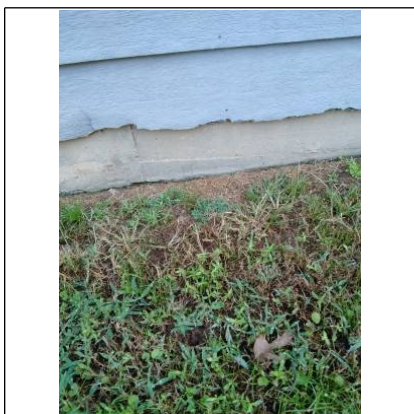
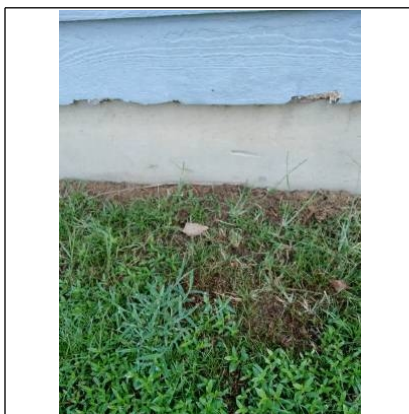
Siding

Material Fiberboard Peeling paint

Condition Marginal Recommend repair/painting

Comments Water damage on lower siding

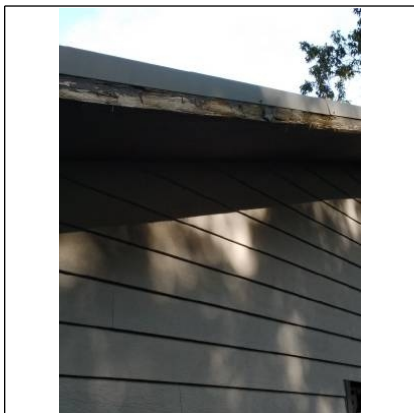
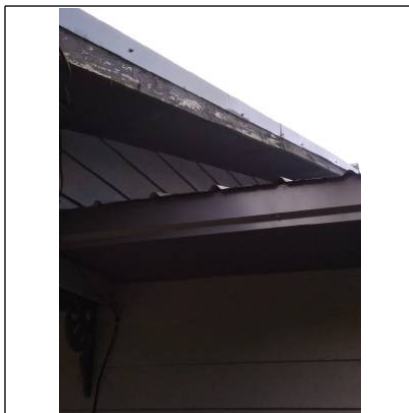
Trim cont.

Comments Some rotted trim boards recommend repair/replacing damaged sections

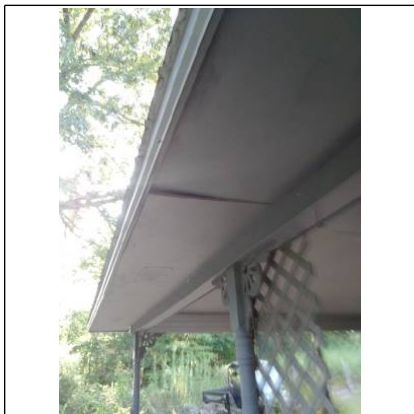
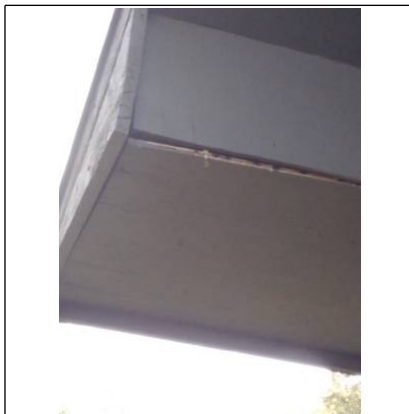
Soffit

Comments Sagging, recommend repair/re-securing.

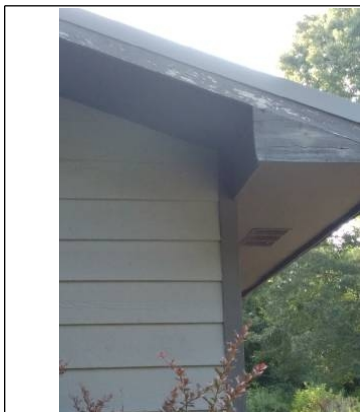
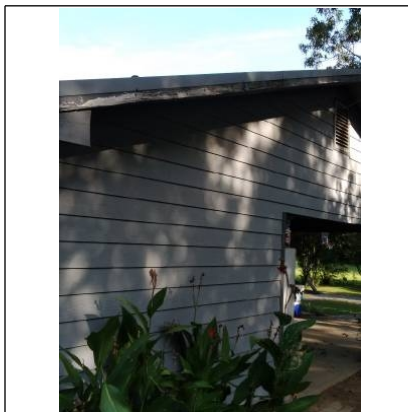
Comments Fascia rotted/damaged, recommend repair

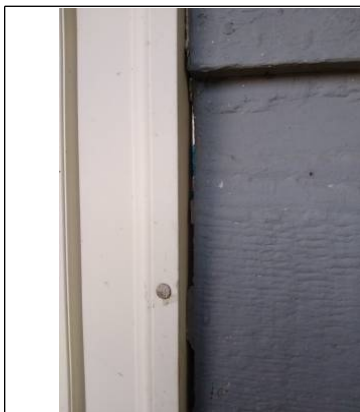
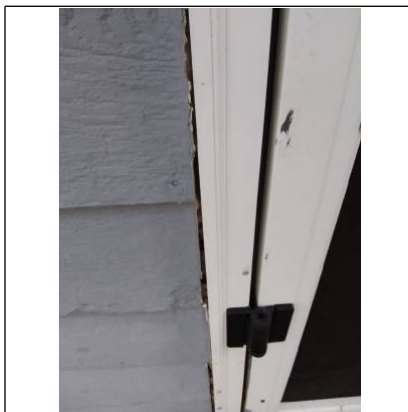
Caulking

Condition Marginal Recommend around windows/doors/masonry ledges/corners/utility penetrations

Comments Recommend caulking around windows, doors, corners, utility penetrations.

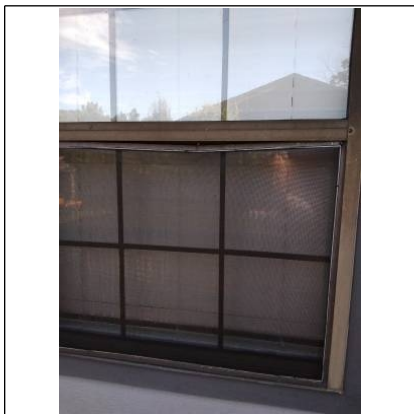
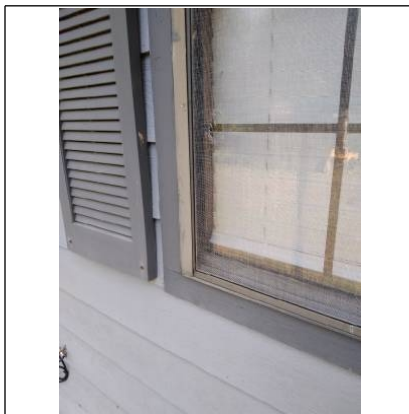
Windows/Screens

Screens Torn Bent

Comments Some screens are torn recommend repair
Windows collect moisture in early morning

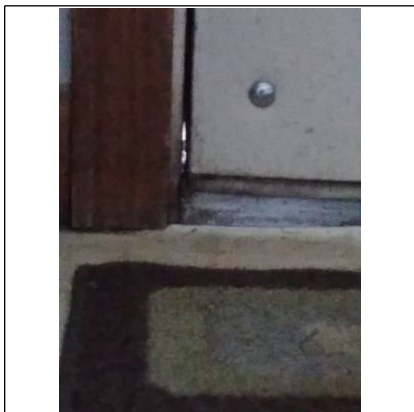
Exterior Doors

Comments Recommend weather stripping replacement on rear door

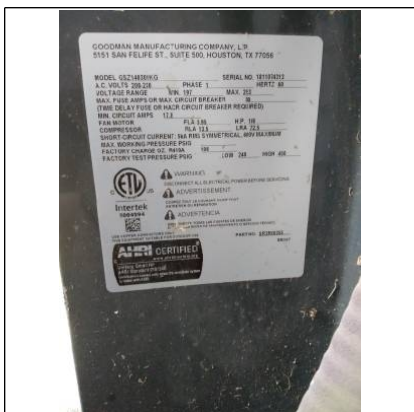
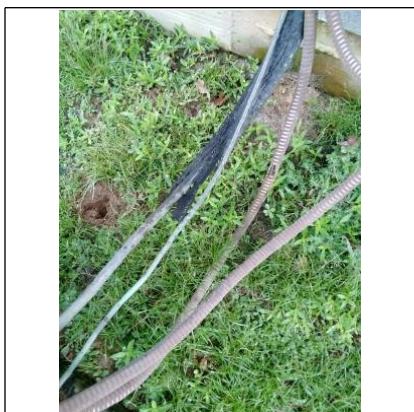
Exterior A/C - Heat pump #1

Level Recommend re-level unit

Condenser Fins Need cleaning

Comments Damaged/Missing insulation recommend replacing insulation

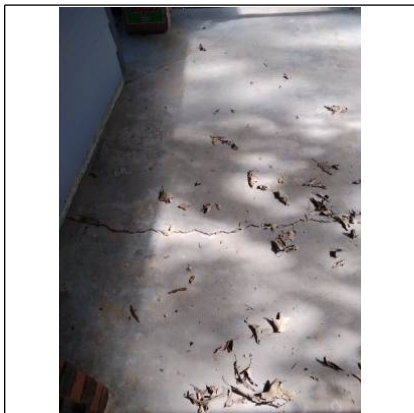
Garage/Carport

Comments 1-car. Settlement cracks

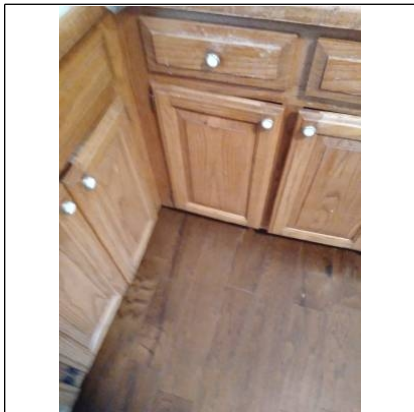
Cabinets

Condition Recommend repair/adjustment

Comments Some doors do not close properly

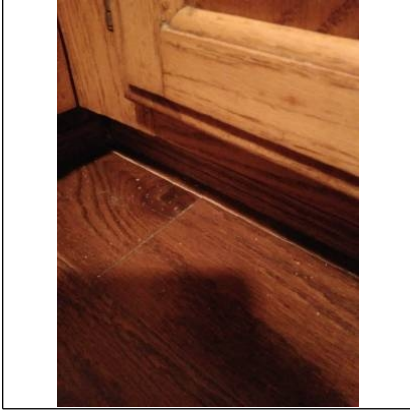
Floor

Comments Some separation at cabinet edge.

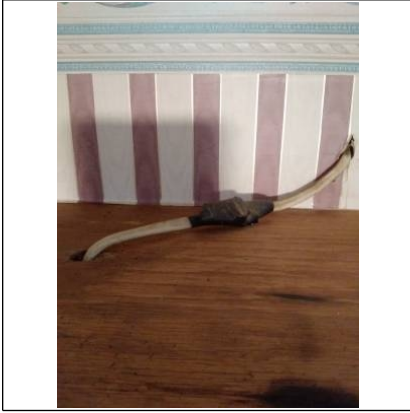
Appliances

Other One burner on front right of stove top inoperable Operable: Yes No

Non-professional wiring for oversink lighting recommend repair by qualified technician

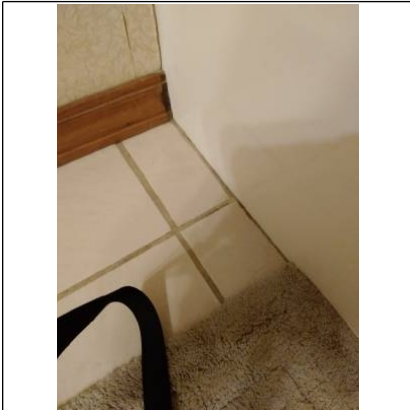
Bath

- Location** Off hallway in back of house
- Sinks** Faucet leaks: Yes No Pipes leak: Yes No
- Tubs** Faucet leaks: Yes No Pipes leak: Yes No Not Visible
- Showers** Faucet leaks: Yes No Pipes leak: Yes No Not Visible
- Toilet** Bowl loose: Yes No Operable: Yes No
- Shower/Tub area** Ceramic/Plastic Caulk/Grouting needed: Yes No
Where: Caulking needed around tub/floor and sink backsplash
- Drainage** Satisfactory
- Water flow** Satisfactory
- Moisture stains present** Yes Walls
- Doors** Satisfactory
- Window** None
- Receptacles present** Yes Operable: Yes No
- GFCI** Yes Operable: Yes No
- Open ground/Reverse polarity** No
- Heat source present** Yes
- Exhaust fan** No
- Comments** Water staining on baseboards. Not wet at time of inspection. Toilet loose, recommend qualified technician determine fix.

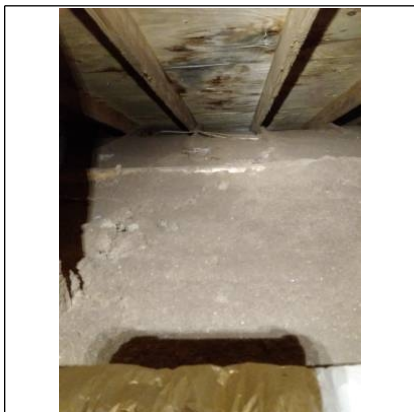
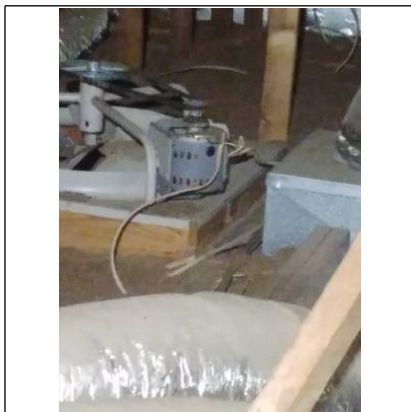
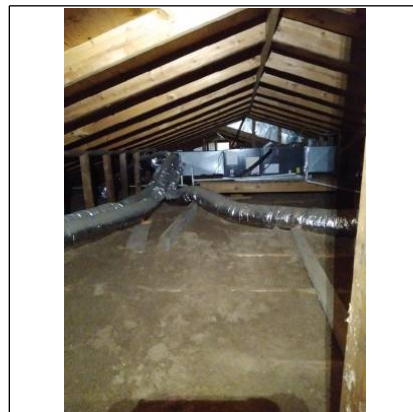
Attic/Structure/Framing/Insulation

Access Pulldown Access limited by: Ductwork
Inspected from In the attic
Location Other
Flooring Partial
Insulation Batts Cellulose Missing Recommend additional insulation
Installed in Between ceiling joists
Vapor barriers Not Visible
Ventilation Ventilation appears adequate
Fans exhausted to Attic: Yes No Recommend repair
HVAC Duct Satisfactory
Chimney chase Satisfactory
Structural problems observed No
Roof structure Rafters Wood Knee wall
Ceiling joists Wood
Sheathing OSB
Evidence of condensation No
Evidence of moisture No
Evidence of leaking Yes
Firewall between units N/A
Electrical Handyman wiring Knob and tube covered with insulation Safety Hazard
Comments At whole house fan, exposed wiring at motor
 Whole house fan was covered and untested.
 Water staining visible in attic but dry at time of inspection
 No light in attic....safety hazard

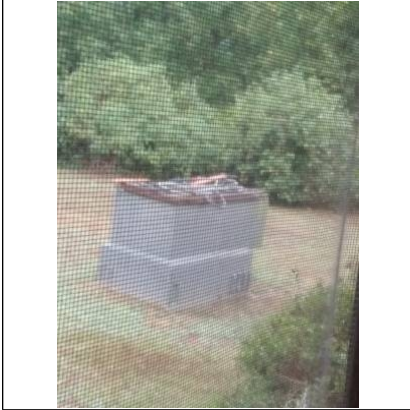
Well pump

Type Well house
Pressure gauge operable No
Comments Well inoperable, breaker is off

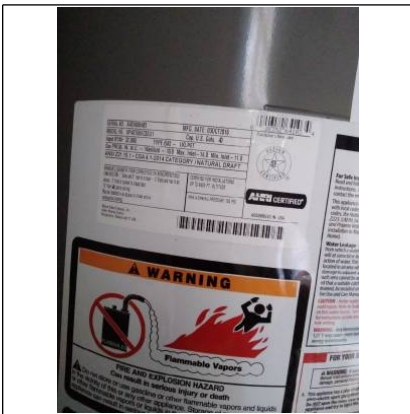
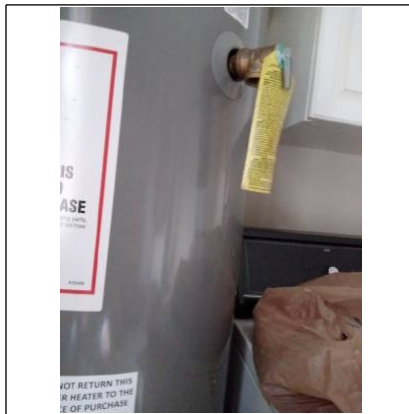
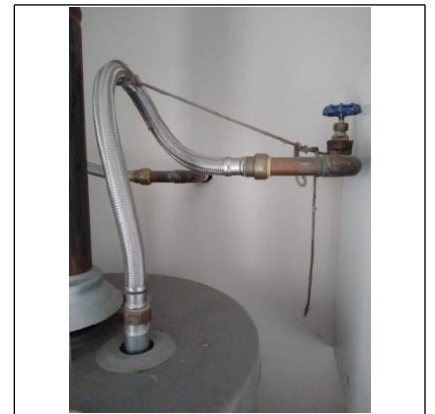
Water heater

Relief valve Yes Extension proper: Yes No Missing Recommend repair Improper material

Comments Temperature-Pressure relief valve extension should be 4"-6" off of the floor - this is a Safety Concern.

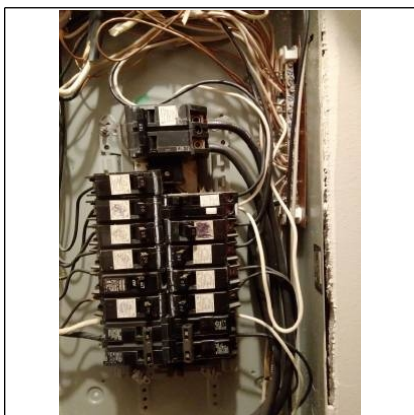
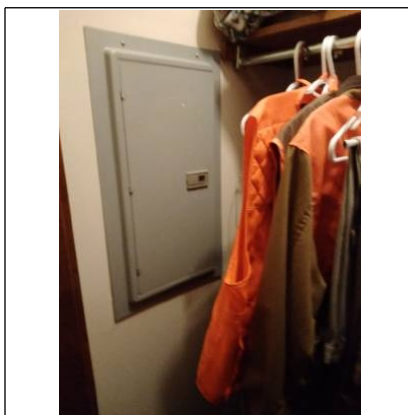
Main panel

Adequate Clearance to Panel No

Comments Panel too close to clothing

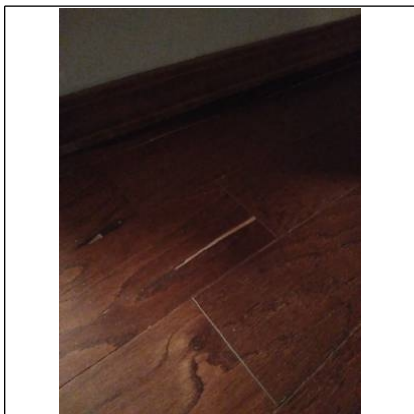
Living Room

Comments Windows covered in moisture. Recommend evaluating by qualified technician. Floor sections loose or damaged in areas
