Home Inspection Report

123 abc Road, mytown, AR 12345

Wednesday May 5, 2021

Skyline Inpections LLC
115 Bold Springs Road
Strawberry , AR 72469
(870)232-1249
tombaker@skyline-inspections.com

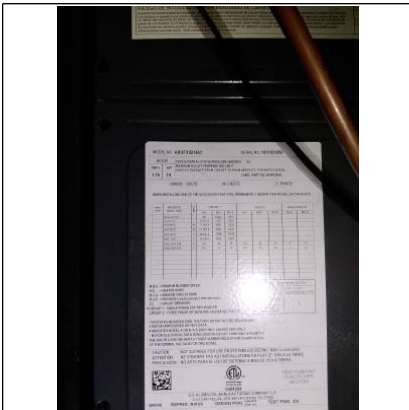
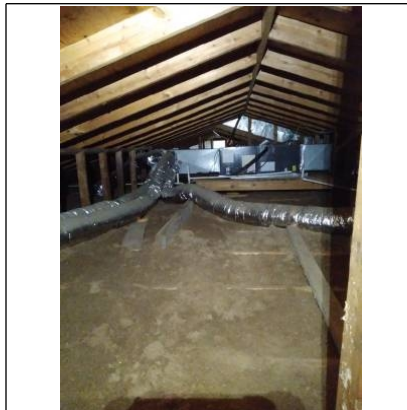
- Unit #1** Brand name: Goodman
 Approx. age: 1-5+
 Model #: ARUF31B14AC Serial #: 1811301050 Satisfactory
- Unit #2** None
- Energy source** Electric
- Warm air system** Direct drive
- Heat exchanger** Not Visible
- Carbon monoxide** N/A Not tested
- Combustion air venting present** N/A
- Controls** Disconnect: Yes No Normal operating and safety controls observed Gas shut off valve:
 Yes No
- Distribution** Insulated flex duct
- Flue piping** N/A
- Filter** Standard Needs cleaning/replacement
- When turned on by thermostat** Proper operation: Yes No Not tested
- Heat pump** Supplemental electric
- Sub-slab ducts** N/A
- System not operated due to** Exterior temperature
- Comments** Heater was not operated due to extreme outside temperatures during inspection
